## **Reference 13**

**Falcon Refinery  
TXD 086 278 058**

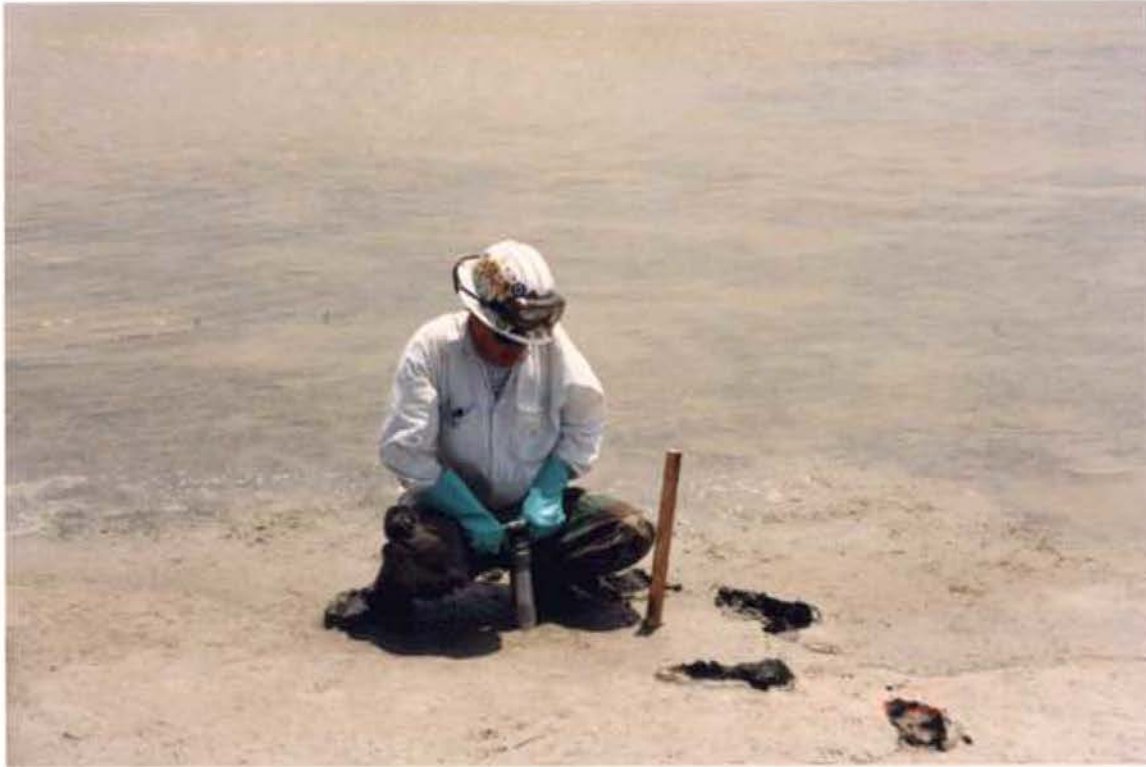
Roll #3 Photo 4 - 5/18/2000 Taken by: M.Cordell. Sampler: M. Cedilote. Collection of Sample SE-15, east of FM 2725. Direction: Southeast.

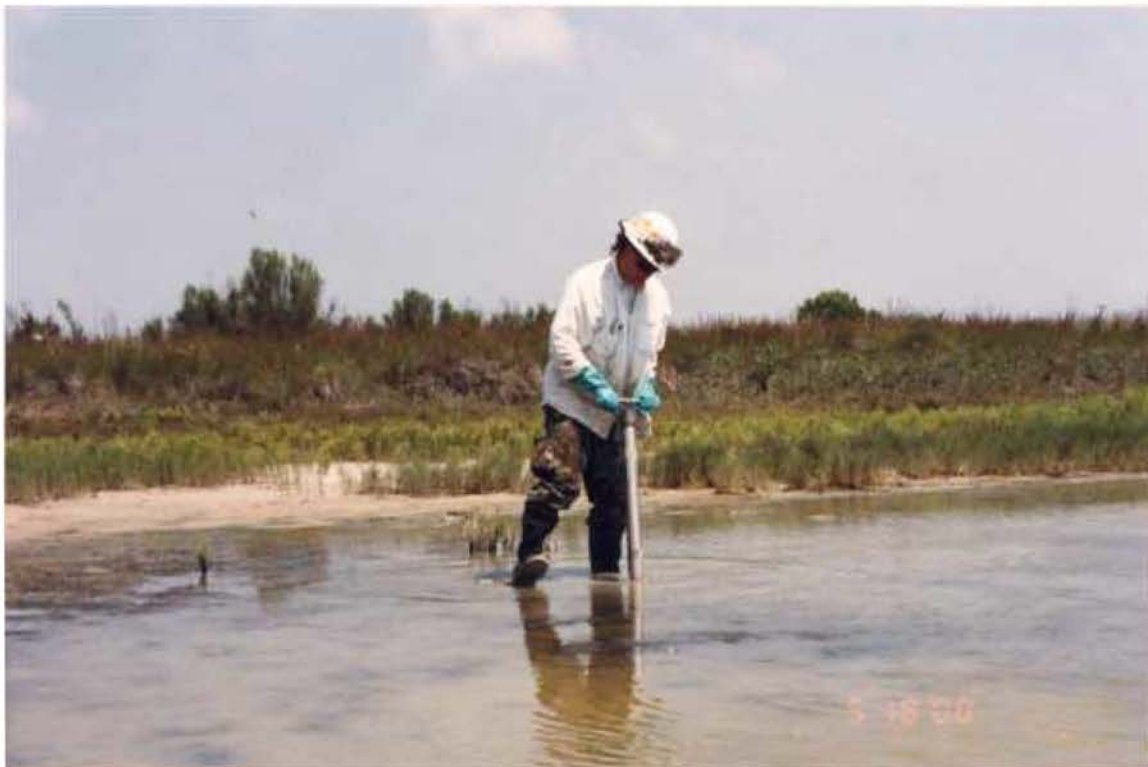
Roll #3 Photo 5 -5/18/2000 Taken by: M. Cordell. Sampler: M. Cedilote. Collection of Sample SE-16 at link between wetlands north of Sunray Road and wetlands south of Aker Gulf Marine. Direction: Northeast.

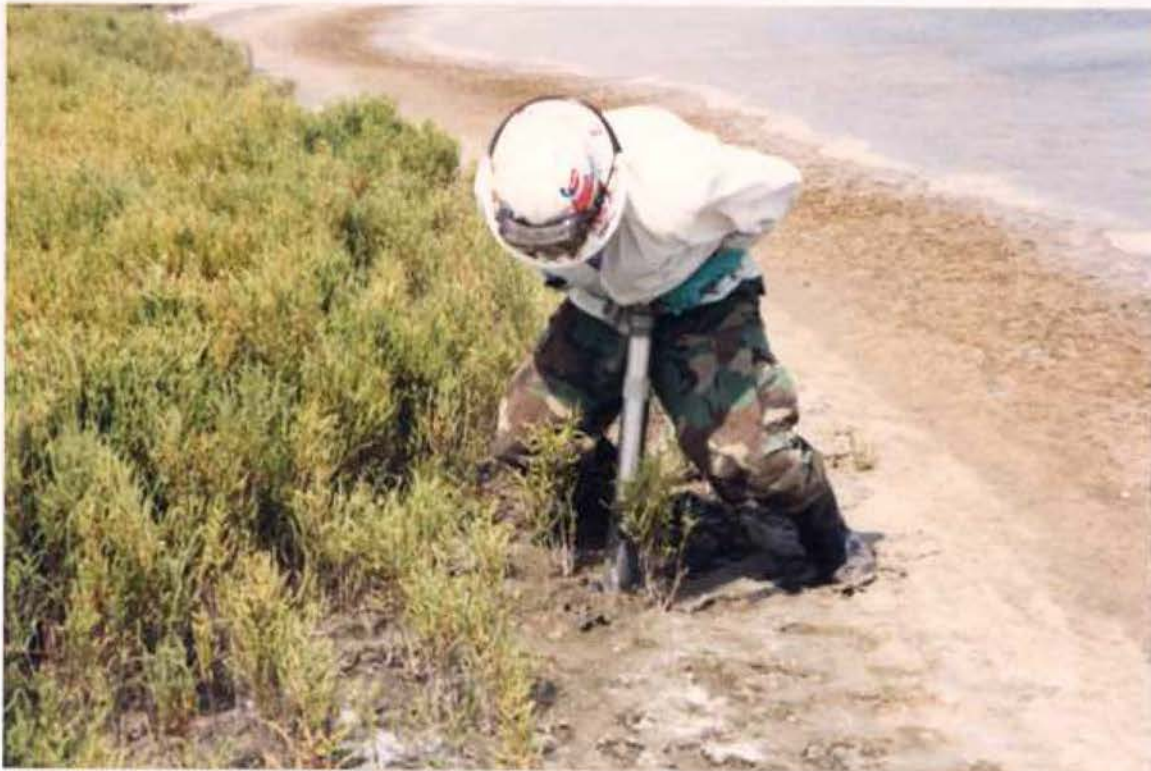
Roll #3 Photo 6 - 5/18/2000 Taken by: M. Cordell. Sampler: M. Cedilote. Collection of Sample SE-18 located by Bishop Road. Direction: Northeast.

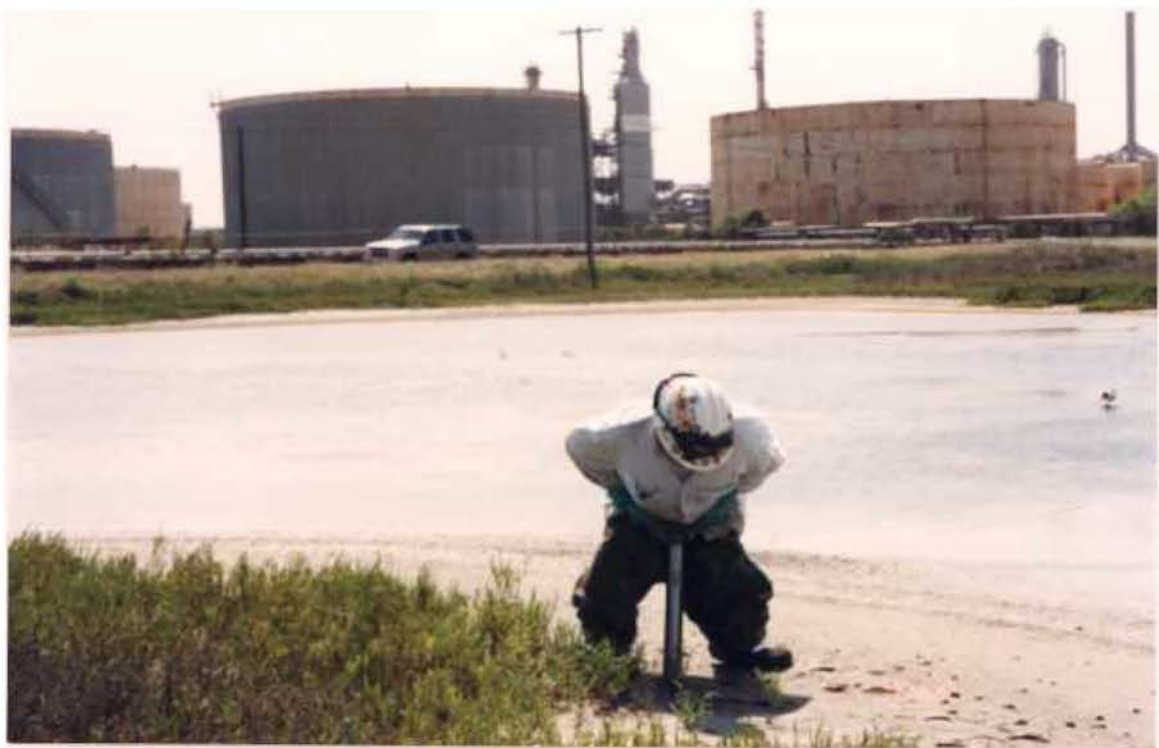
Roll #3 Photo 7 - 5/18/2000 Taken by: M. Cordell. Sampler: M. Cedilote. Collection of Sample SE-19, north of Bishop Road. Direction: Southwest.

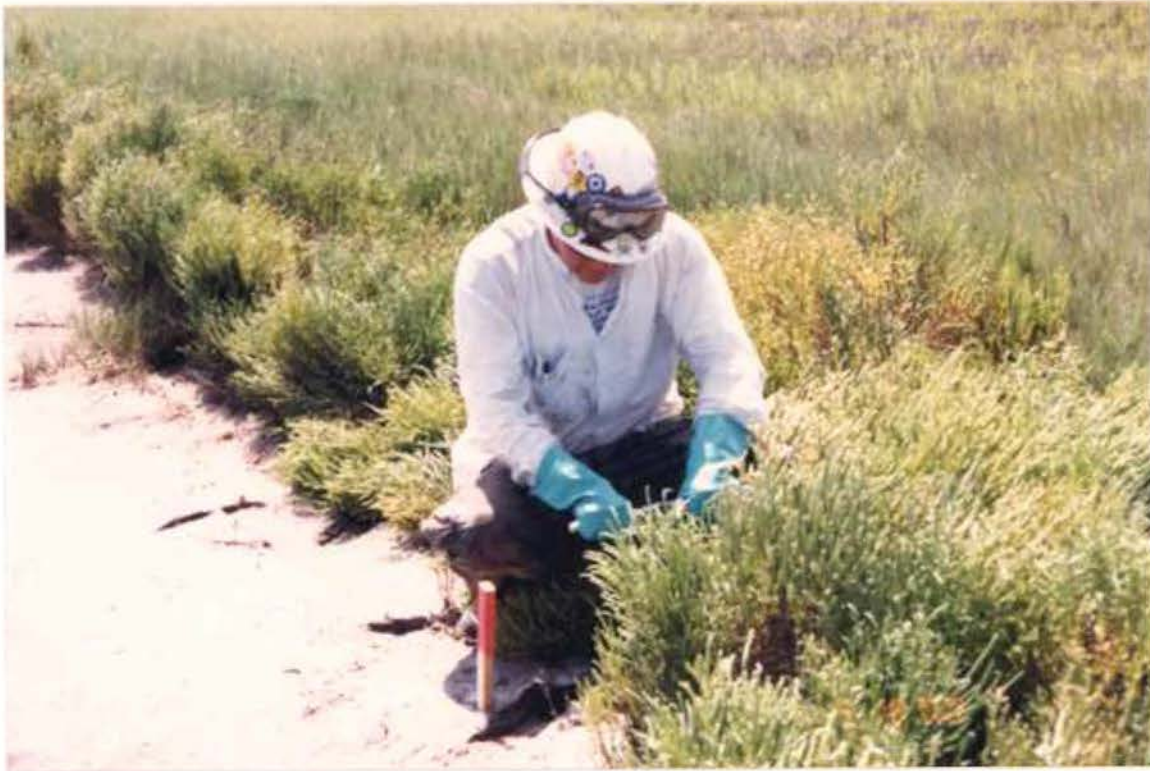
Roll #3 Photo 8 - 5/18/2000 Taken by: M. Cordell. Sampler: M. Cedilote. Collection of Sample SE-17, south of Sunray Road. Direction: Southeast.

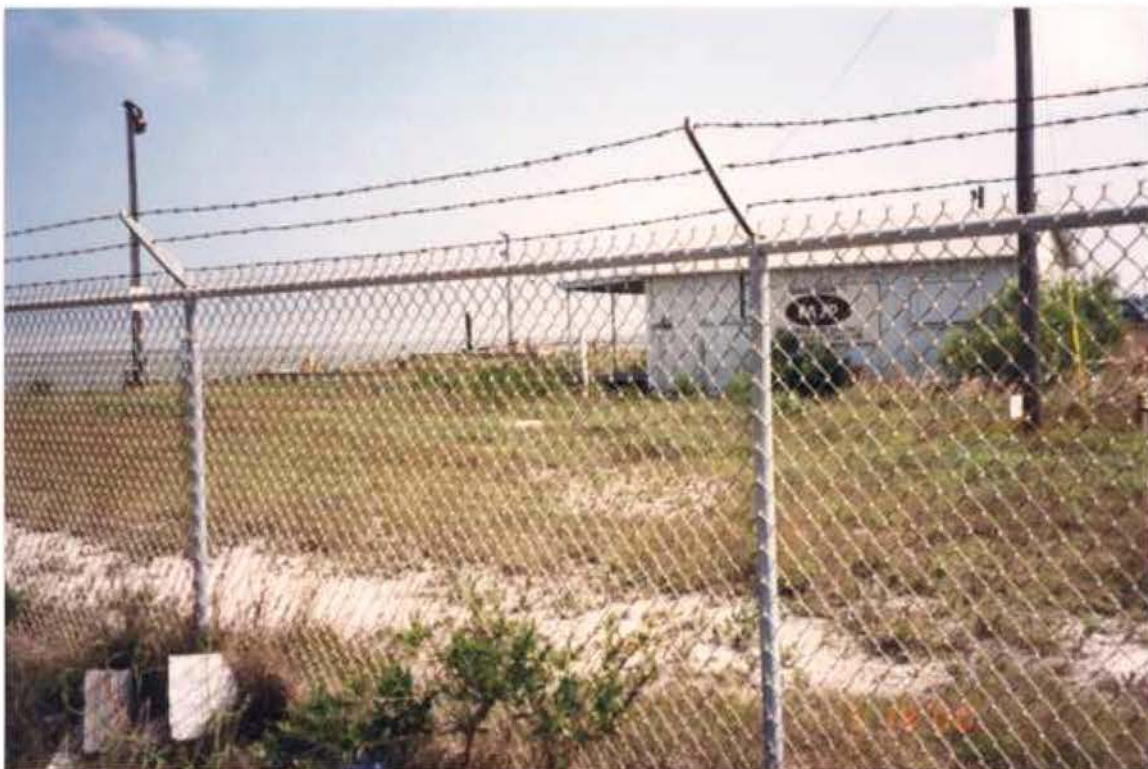
Roll #3 Photo 9 - 5/18/2000 Taken by: M. Cordell. MJP Resources, Inc. Barge Dock #1 aka NORCO. Direction: Southeast

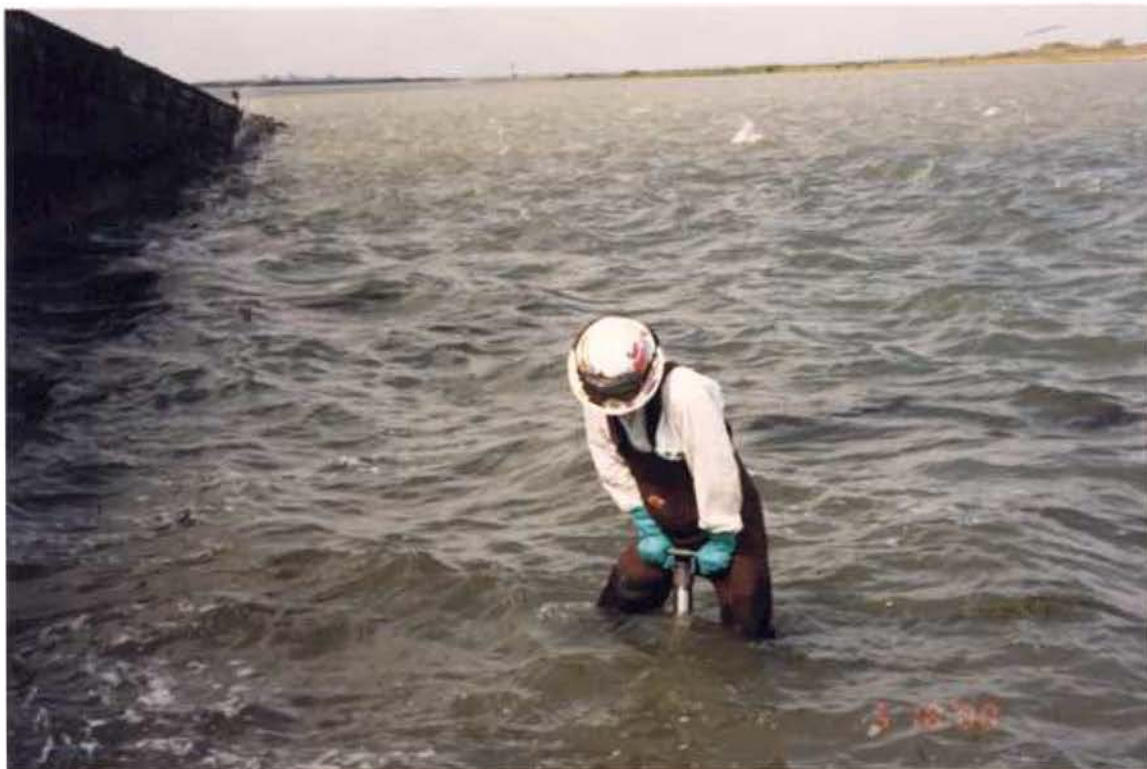
Roll #3 Photo 10 - 5/18/2000 Taken by: M. Cordell. Sampler: M. Cedilote. Collection of Sample SE-02 in Redfish Bay, northeast of the MJP Resources, Inc. Barge Dock #1. Direction: Northeast.

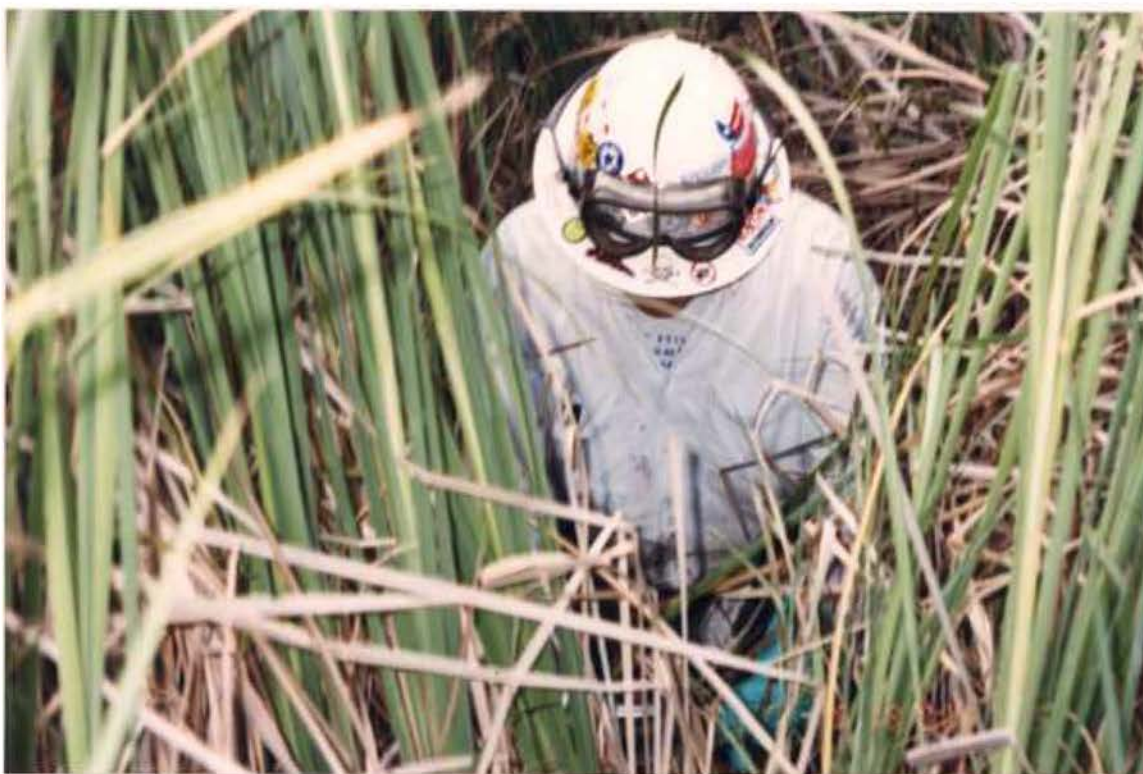
Roll #3 Photo 11 - 5/18/2000 Taken by: M. Cordell. Sampler: M. Cedilote. Collection of Sample SE-32 and SE-33 in wetlands near location of 1995 pipeline leak. Direction: West.

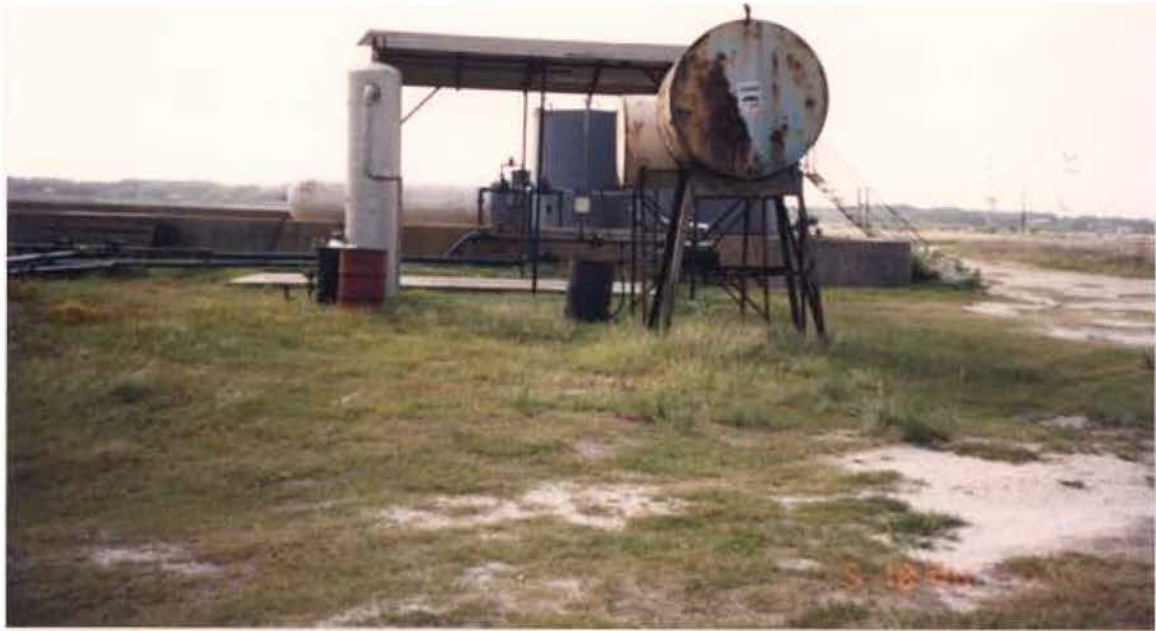
Roll #3 Photo 14 - 5/18/2000 Taken by: M. Cordell. Aboveground storage tank (AST) located on IBC Petroleum. ASTs are also located on Pi Energy behind the retaining wall. Direction: Northwest.

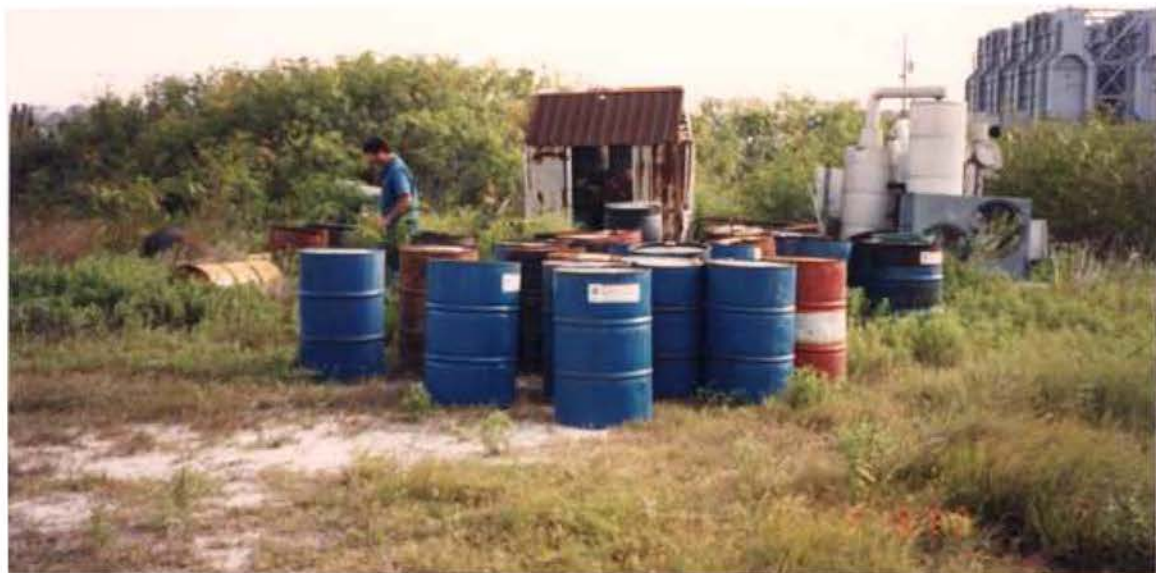
Roll #3 Photo 15 - 5/18/2000 Taken by: M. Cordell. Drums located on the IBC Petroleum property. Direction: Northwest.

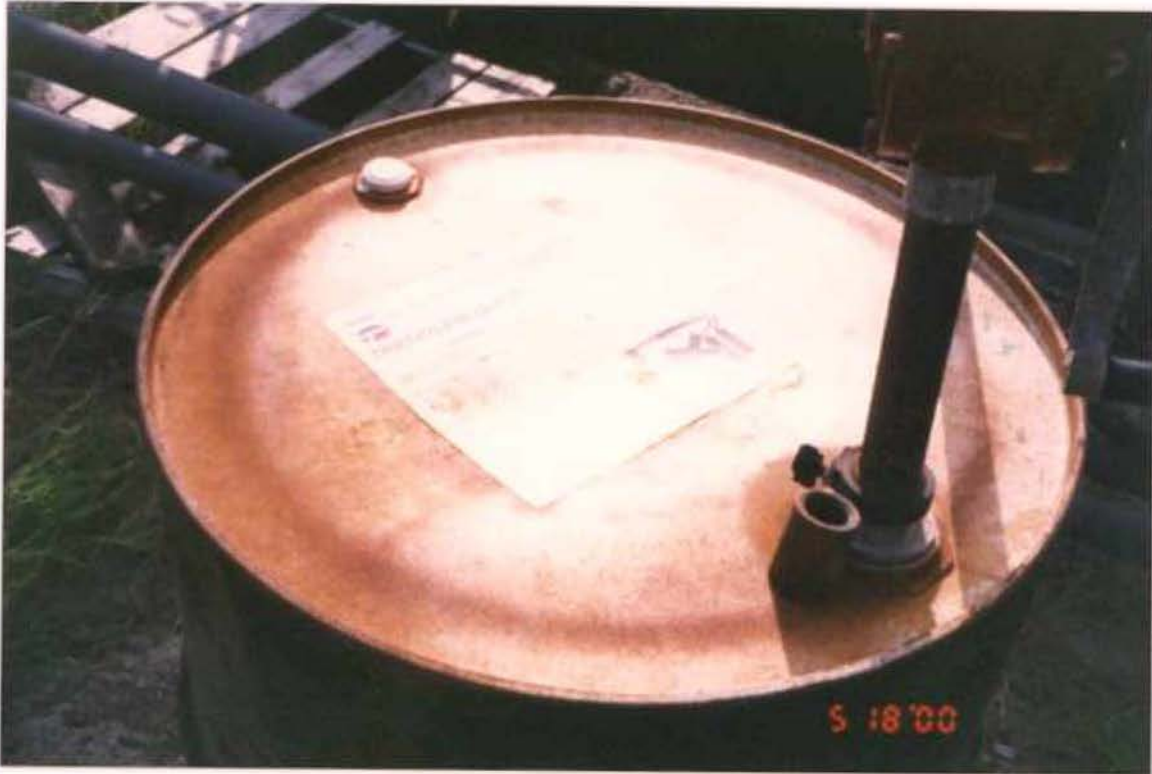
Roll #3 Photo 16 - 5/18/2000 Taken by: M. Cordell. Drum labeled Triethylene glycol on IBC Petroleum property. Direction: Northwest.

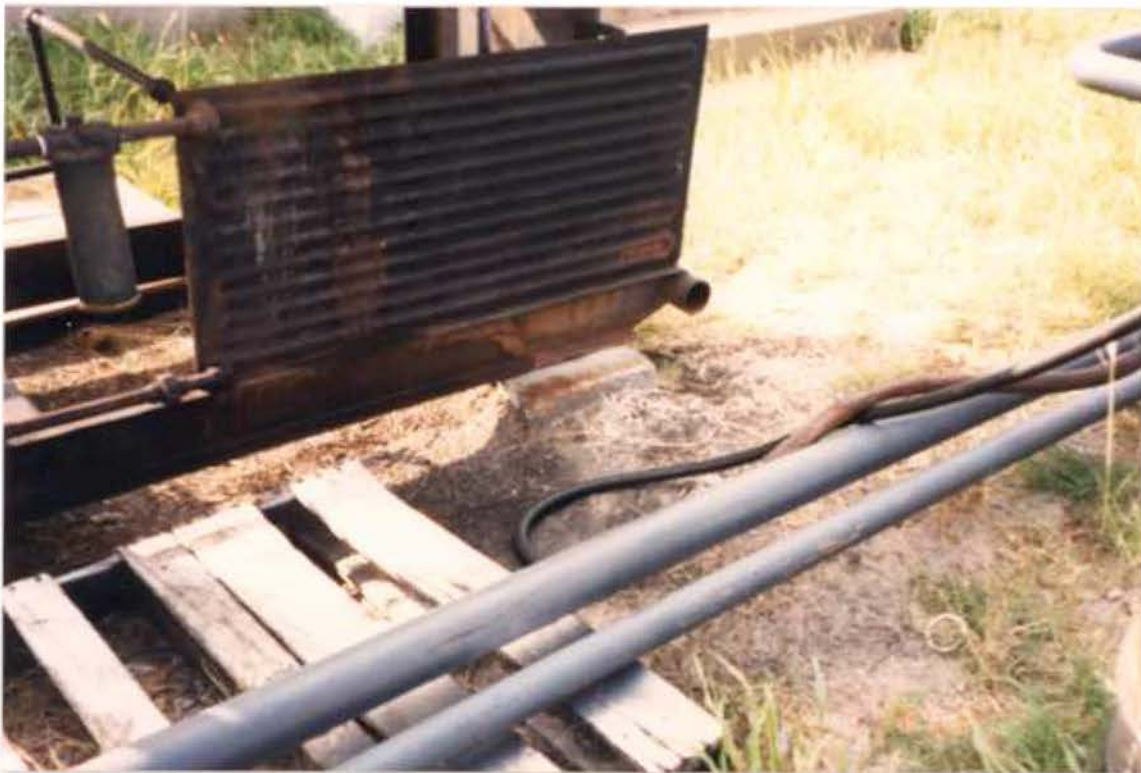
Roll #3 Photo 17 - 5/18/2000 Taken by: M. Cordell. Leaking liquid from equipment on IBC Petroleum property that appears to be connected to equipment on the Pi Energy property. Direction: Northwest.

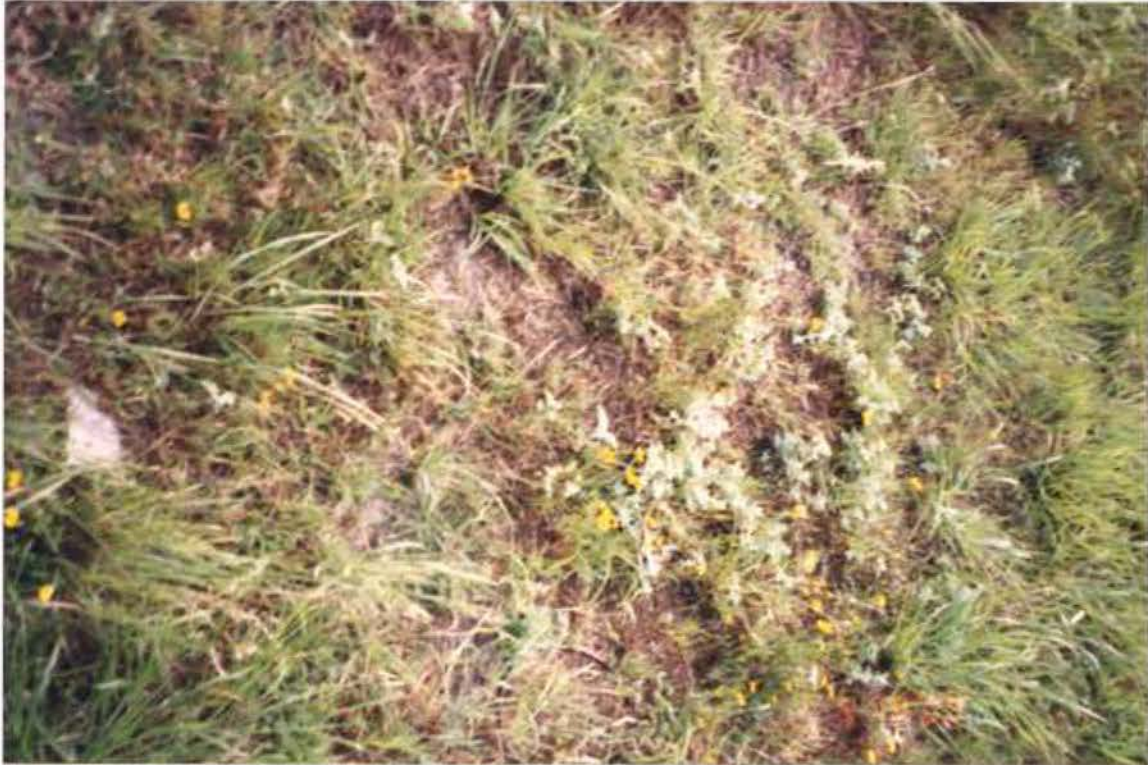
Roll #3 Photo 20 - 5/18/2000 Taken by: M. Cordell. Appearance of runoff of material on IBC Petroleum property. Direction: Southwest.

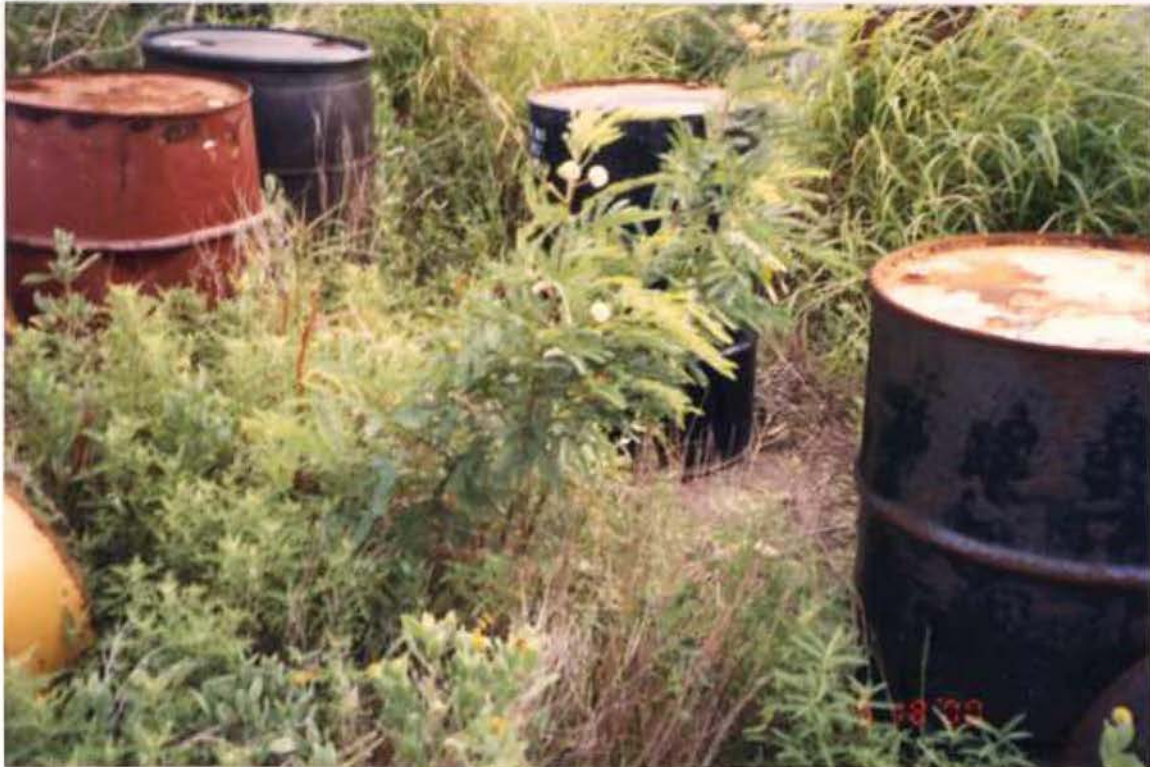
Roll #3 Photo 22 - 5/18/2000 Taken by: M. Cordell. Drums on IBC Petroleum property. Direction: Southwest.

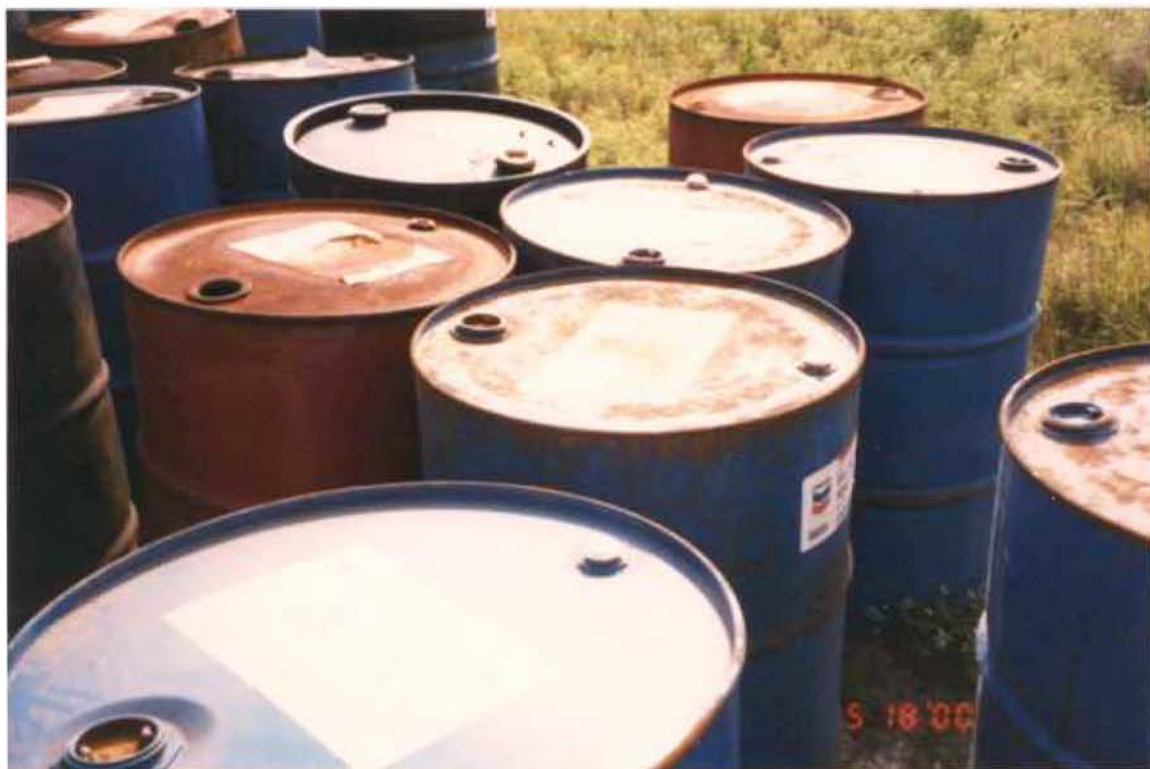
Roll #3 Photo 23 - 5/18/2000 Taken by: M. Cordell. Drums on IBC Petroleum property. Direction: Southwest.

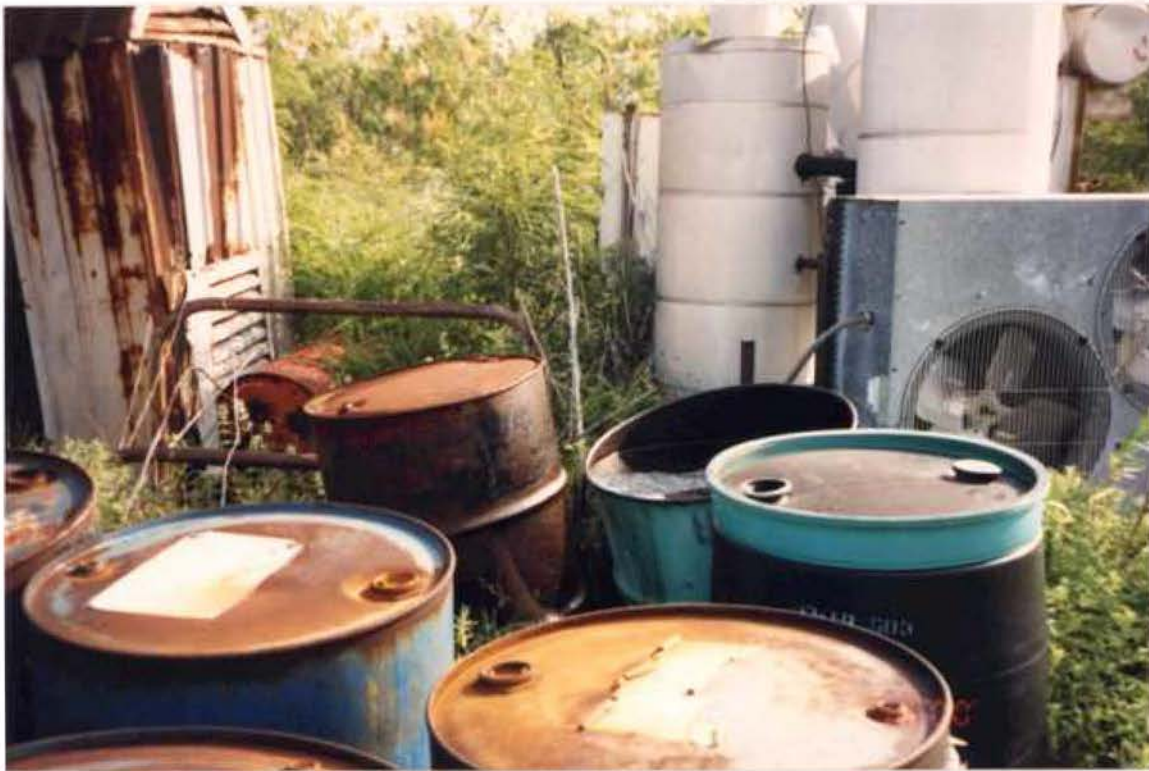
Roll #3 Photo 24 - 5/18/2000 Taken by: M. Cordell. Drums on IBC Petroleum property. Direction: Southwest.

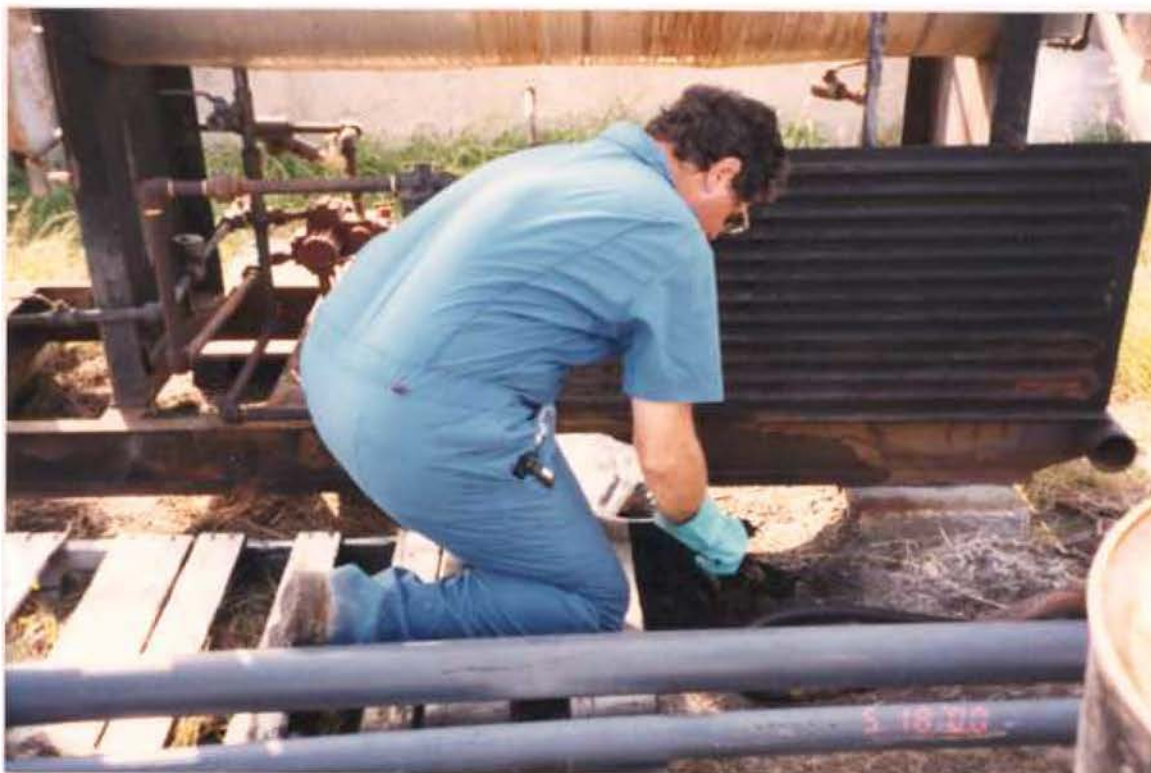
Roll #3 Photo 25 - 5/18/2000 Taken by: M. Cordell. Sampler: W. Newberry. Collection of Sample SO-05 from area of leaking equipment. Direction: Northwest.
